INVESTIGATION OF GROUND AND FOUNDATION CONDITION INFLUENCE ON THE SPASO-PREOBROZHENSKAYA CHURCH CONSTRUCTIONS IN POLOTSK

In the article the problems of the XII century architecture monument preservation – Spaso-Preobrazhenskaya church of Spaso-Efrosinievskiy convent in Polotsk are considered. A brief reference is given on the technical condition and design features of the facility. Various parameters research results allows to estimating bearing constructions technical condition. The issues of bearing structure geodetic, visual, instrumental and electronic remote monitoring complex implementation and organization are considered. The issues of innovative technology introduction for this research area such as ground-based three-dimensional laser scanning are covered. There was made a conclusion church foundation conditions and there are given recommendations as for their strengthening.

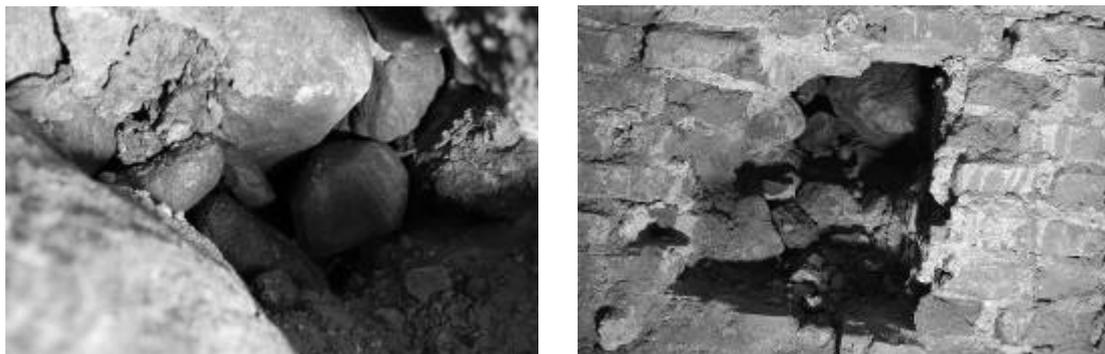
The material for the foundation of the church is rubble stone, laid with incomplete filling of seams. In archaeological excavations there are foundations with the laying of stones «dry» and the presence of residues (decay) of oak stands (Figure 3). The total height of the basement foundation is on the average 90 cm, and the height of the walls masonry is at a certain level below the level of the existing planning mark – about 100 cm. In the masonry wall solution contains a large amount of cement.

Figure 3 – Results of the structure opening to determine the technical state of foundations under the pillars

In the places of absence or rubble foundations boulders selection, a bookmark of new ones is necessary. Formed cavities between the boulders of foundations should be filled with a lime solution.

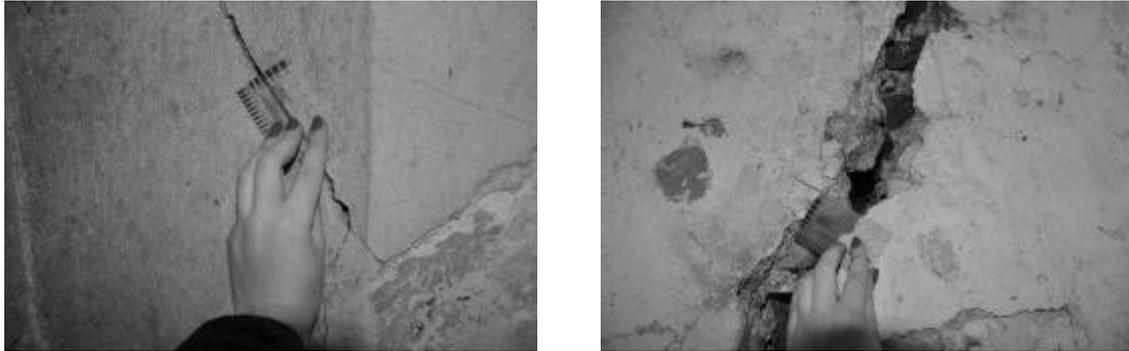
Within the walls of the church, cracks with different opening widths (from 0.05 to 75 mm) were identified (Figure 4). Cracks have sedimentary character. At the junction of the cell wall with the outer wall there is no bandage between the rows of wall masonry, which allows exchanging between the outer walls and inner pillars. In the pillars longitudinal and transverse cracks are revealed. The pillars have general tendency towards the exterior walls of the building. Longitudinal and inclined cracks are revealed in the laying of the kokoshniks.

According to the totality of moral and physical deterioration signs, the technical condition of the building constructions is generally characterized as unsatisfactory, requiring measures for repair and reinforcement. Physical wear of structures is 40...80%.

Figure 4 – Measurement of crack opening width in church structures

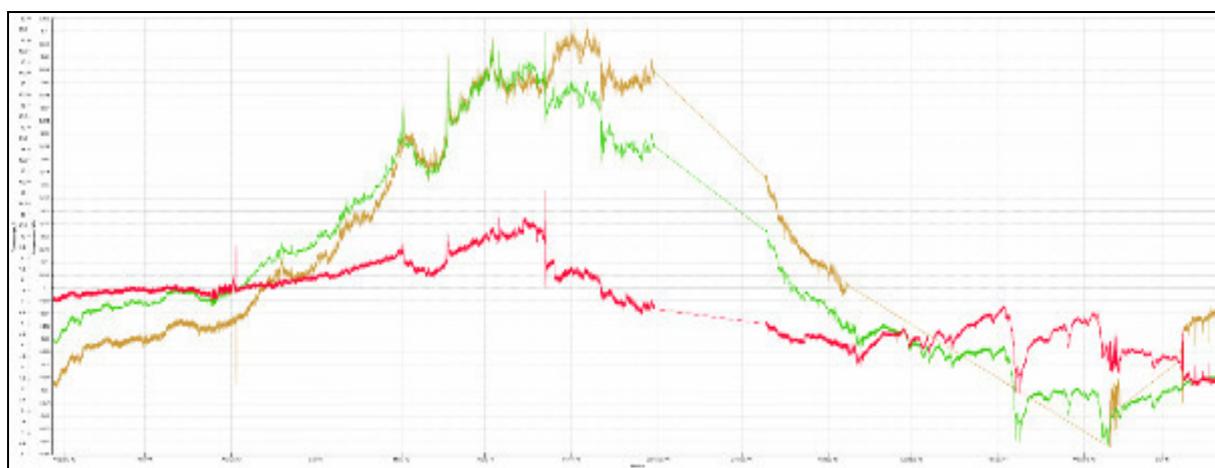
Figure 6 – Graph of changes in temperature and stresses occurring in pillar structures from December 2015 to March 2017

When analyzing the data of load-carrying structures electronic monitoring, it is established that not all structural elements work in the same way with temperature changes and the effect of temporary loads. The work of two pillars and the southern wall does not correspond to elastic work. The change in their stress-strain state cannot be simulated and, in some cases, works separately from the basic structures of the church. This is due to the base sediment and the insufficient bearing capacity of the foundations. The work of the crypts pillars is complicated, toward which the foundations of the pillars are shifted. It is necessary to take urgent measures to strengthen the foundation and foundations under the pillars. The crypt walls do not work in the elastic stage, deforming the stent inside the crypt. There is no unification of the crypt walls with the arch. The ability of walls to perceive Effective loads from ground pressure and loads transmitted from the pillar can be lost if the necessary measures are not fully implemented.

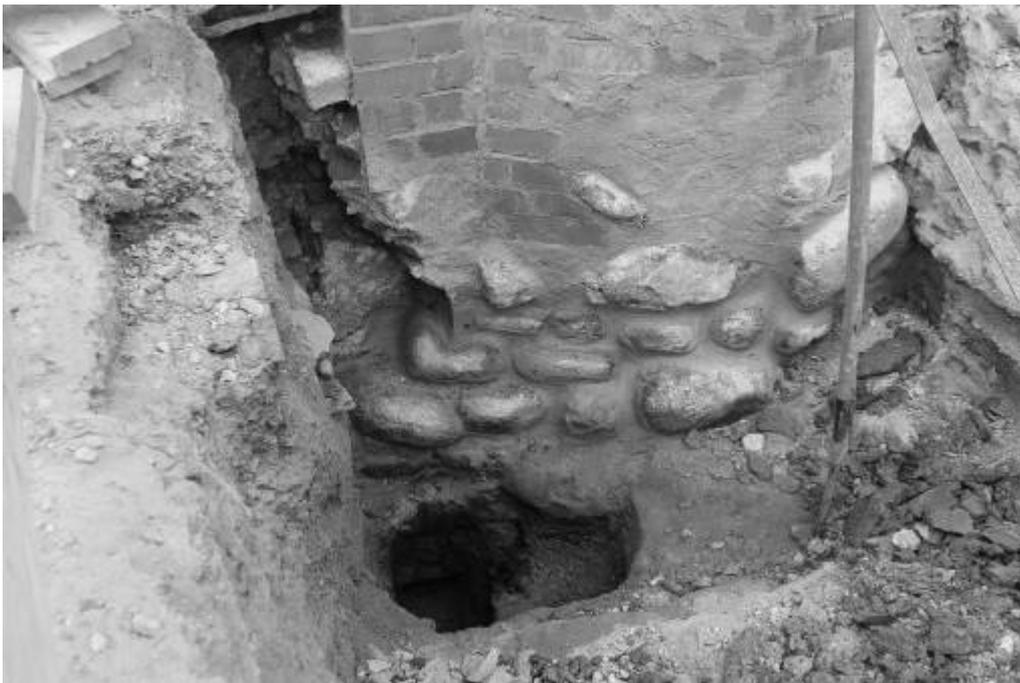
When performing the refined, 7 pits were made (Figure 7).

Figure 7 – General view of the pit on the south side of the temple
