RESIDENTIAL BUILDING'S DEFORMATION ON PILE FOUNDATION

Vynnykov Yuriy^{1*}, Manzhaliy Sergiy²

A considerably distinctive deformed five-storeyed three-section brick residential house erected over 40 years ago on driven prismatic piles combined by a strip grid foundation by a standardized project is under investigation. The geotechnical monitoring results of the building's technical condition are presented. Methods and results of the instrumental control analysis of the piles' actual length and visual evaluation of their integrity are presented. The causes of the foundations base's excess deformation were determined: the inability of the piles' tips to reach the designed mark; the piles' destruction during their immersion in dense sands; rupture of the primary thermal network, which led to "negative friction" effect on the piles' lateral surface, etc.

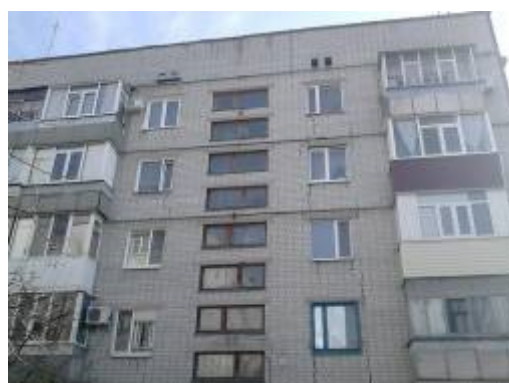
Figure 1 – Fragment of the left block section on the axis B

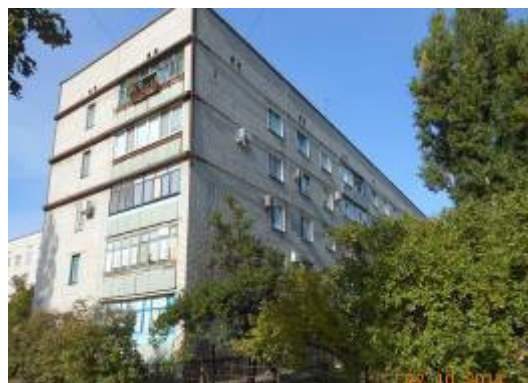
Figure 2 – View of the left side block section in the axes A-B and on the axis A

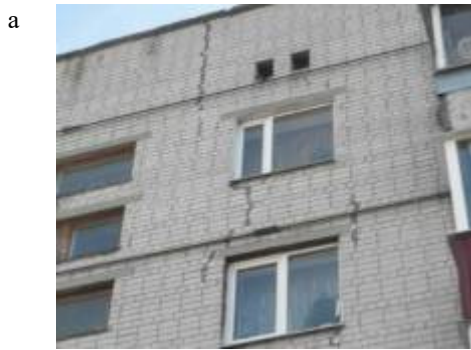
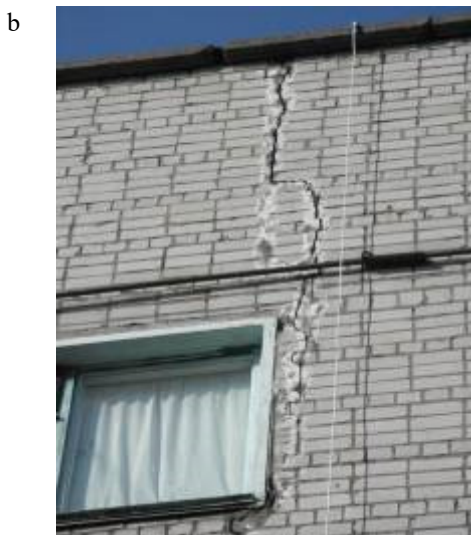
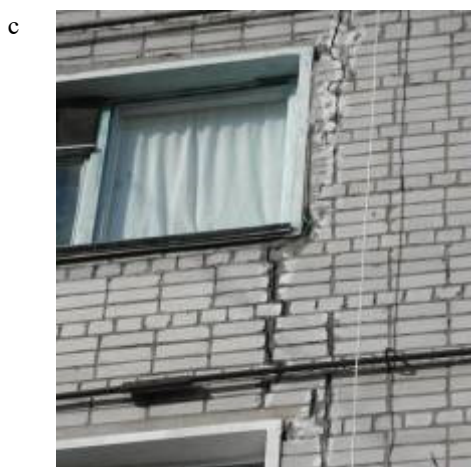
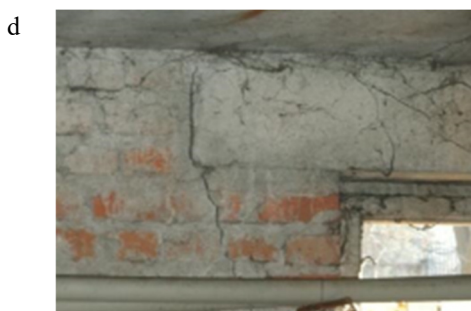
Thus, vertical cracks (Fig. 3) were detected at the entire height in the outer load-bearing walls, mainly at the places of the spandrel beam supporting and over (under) the openings.

Cracks are typical for buildings with reinforced concrete spandrel beams that cause deformation of the window unit by turning it as a single rigid element. Cracks indicate significant deformation of the foundations' base of the left end section in the direction of separation from the main part of the building. The cracks propagation significantly reduces the spatial rigidity of the section because, for separated parts of the outer and inner walls, the spatial rigidity is no longer provided by the transverse walls of the stairwell. There are no cracks on the outer and inner walls of the staircase, which confirms the previous statements.

Figure 3 – Vertical cracks with opening width:
a – 7 mm; b – 15 mm; c – 12 mm; d – 4 mm

Therefore, the technical condition of the outer and inner bearing walls is classified as unsatisfactory.

- strengthen the outer and inner bearing longitudinal walls to prevent the reduction of its spatial rigidity by dividing them into separate blocks (columns) by cracks. For this purpose it is possible to use already existing inefficient metal structures of reinforcement or to execute reinforcement with outer metal linings from rolling profiles;

- to chipper and rip cracks open with M 100 cement sand mixture (alternatively, injection of these cracks with M 100 solution);
 - eliminate depressurization of the main thermal pipeline at the exit from the right end block section in axes III-IV;

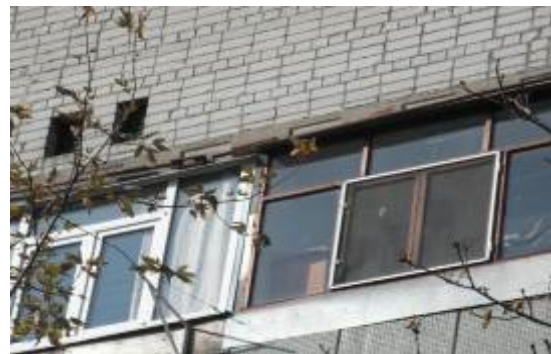
Figure 4 – Break of the upper tension bar along axis A at the level of the fifth floor overlap

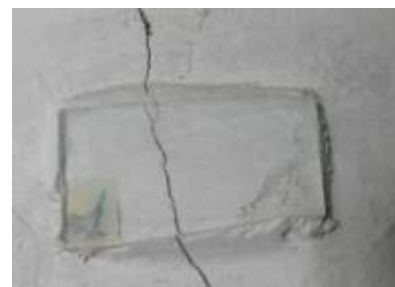
Figure 5 – Crack in the tell-tale (fifth floor)

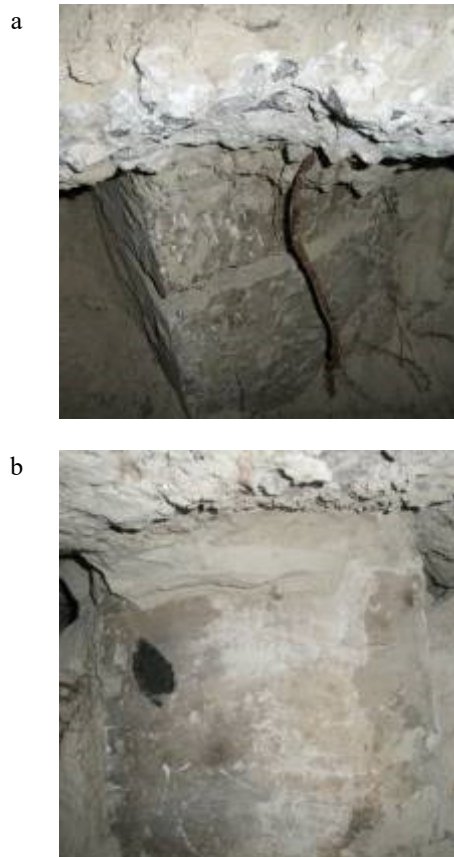
Figure 6 – The piles view as a part of the grid:
a – №1 (pile №119); b – №2 (pile №105)

Shaft / pile №	Actual pile length, m	Notes
1/119*	Pile destroyed	The pile damage due to deviation from the design position while driving. The pile operates on eccentric compression due to the considerable eccentricity of loading and pile's body deflection from vertical. The crack opening in the pile - 40 mm.
2/105*	8.5	–
3/9*	4.5	–
4/77	8.5	–
5/171	6.0	–
6/33	7.5	–

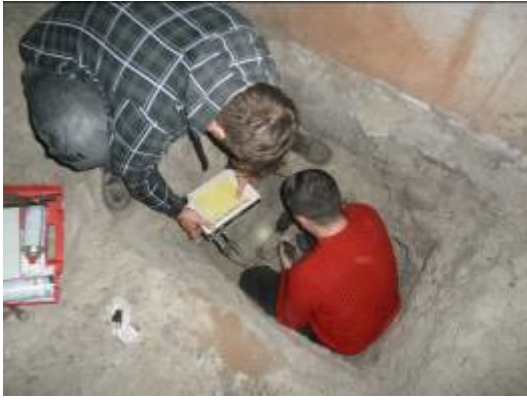
Figure 7 – Performing pile length control work

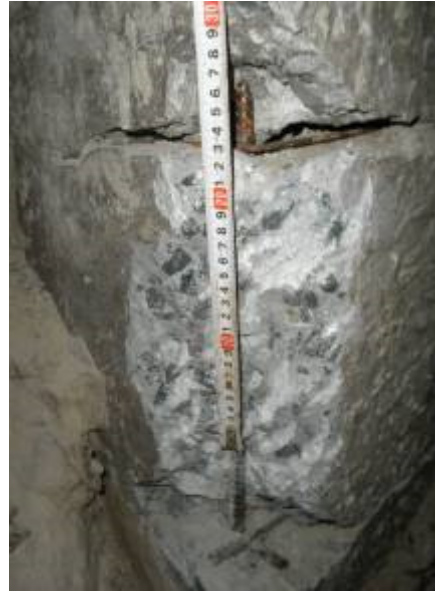
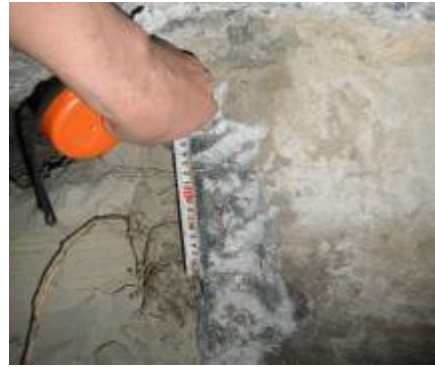
Compared to the nondestructive testing stage, during the investigation of the pile's reinforcement, the exploration shaft was deepened, revealing cracks in the pile body (Fig. 8). The pile was destroyed since the protective layer of concrete was split in a stretched zone. The concrete in the compressed area split and crumbled. The increment of the transverse reinforcement was 200 mm. It shows that the pile was not driven to the designed mark, it was “cut down”. The minimum length of the “cut” part was 600 mm. In this state, the pile does not withstand vertical compressive loads. The results of the instrumental control analysis of the pile's length and visual assessment of their integrity are summarized in Table 1.

The pile reinforcement check confirms the assumption that part of the pile failed to be driven to the design mark. The piles' lengths discovered in the instrumental survey are true. To establish the possible difference in settlement, a test calculation was performed for pile # 119 (shaft # 1) of a 4.5 m length with a cross-section of 350x350 mm. A vertical tie of this pile to the geotechnical column is shown in Fig. 9.

Figure 8 – The piles' view as grid component in pile reinforcement investigation:

- a – pile №119 in shaft №1;
- b – pile №105 in shaft №2 (the reinforcement increment in the survey was 100 mm, therefore, the pile's tip reached the design mark)

- reinforcement of the pile foundations of the left face block section in the I-II axes by underlaying at least 400 mm thickness of monolithic reinforced concrete slab under the existing grids. The underlaying of the slab must be done in four stages, starting from axis II, moving to axis I. To put the plate into operation as soon as it is performed, the base under the slab should be compacted by gravel and pounded with vibrating plates;

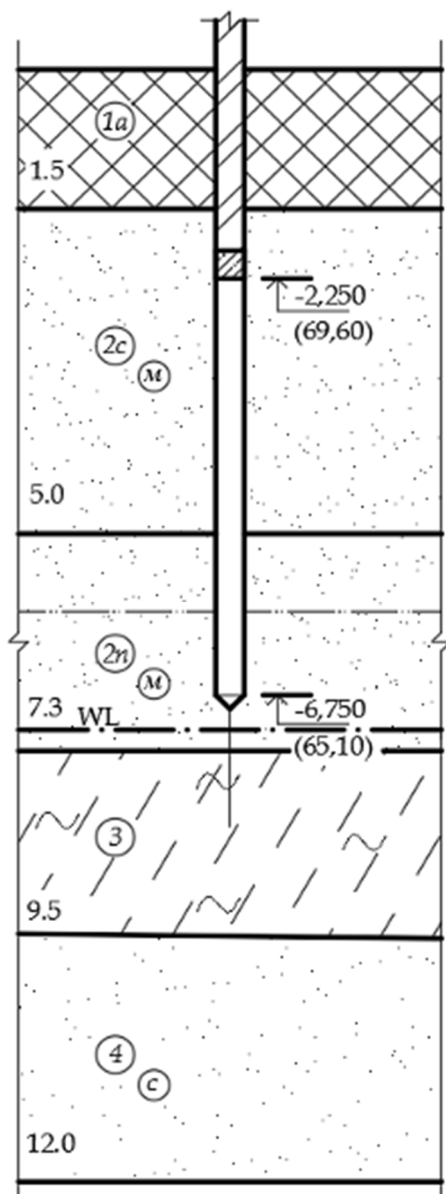
The following results were obtained in the calculation. Settlement of the pile is $S = 2.2 - 2.5$ cm based on the calculation method. Thus, the difference between the settlement of piles with a length of 9 m and 4.5 m is about 1 cm, which could not cause actual over-deformation.

However, given the occurrence of “negative friction” effect due to self-compacting and mechanical suffusion in the upper layers of the bulk sands after rupture of the main thermal pipeline, which was intensified by inertial forces from the explosions in the quarry, the bearing capacity of the pile decreased to $F_d = 375.7$ kN, it is up to $N = 268.0$ kN, which is less than the vertical force from the structures of the building 404.5 kN.

When the permissible load on the pile was exceeded, the pile's foundation base settlement was already in the nonlinear stage, which led to the appearance and development of existing deformations of the building. Provided that if all the piles' tips reached the design mark, then, of course, such deformation would not occur.

Figure 9 – The vertical tie of the pile to geotechnical column according to SNIP 4.5 – 35
