CONSTRUCTIONAL FEATURES OF HEGUMEN HOUSE IN CHERNIHIV

Research results of the XVII century construction, Hegumen House in Chernihiv, are presented. It is a historically significant local landmark. Attention was paid to historical data on foundation of the monastery and structure erection. The construction was built to serve as a refectory church of Peter and Paul. The purpose of the building was found to have been changed repeatedly during its existence. Constructional features of the structure remains were analyzed. Practical recommendations on its restoration were developed. Underground unit drawing was made, which is accessible to viewing. Detailed research was conducted. Reinforcements and brick wall construction, dated at a later period, were discovered. The wall construction brick was analyzed. Much attention was paid to durability and stableness of the underground unit.

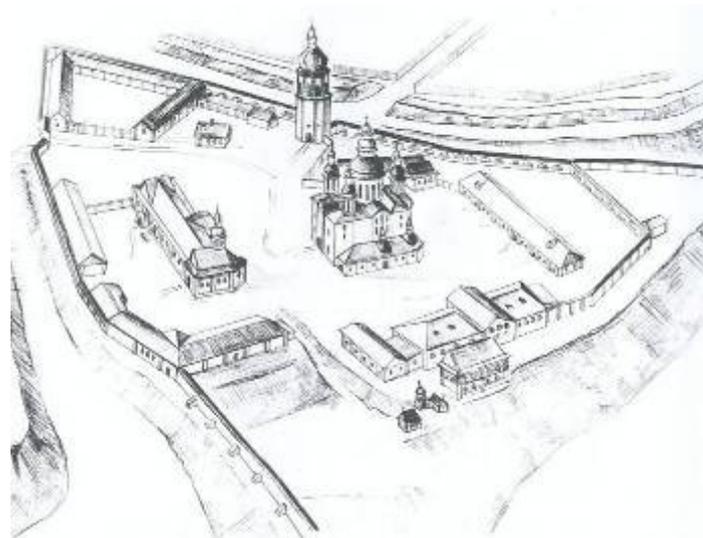
Figure 1 – Renovation of Yeletsky monastery (mid–eighteenth century) by O. Bondar

Built during the Hetmanate, the architectural structure was unique for its time – the largest refectory church on the Left Bank territory (Fig. 1). Its length without extensions and vestibules is more than 46 m and the width is at least 18 m. The wall thickness is more than half a meter, the height of one of the remained premises is about 5 m [3–4].

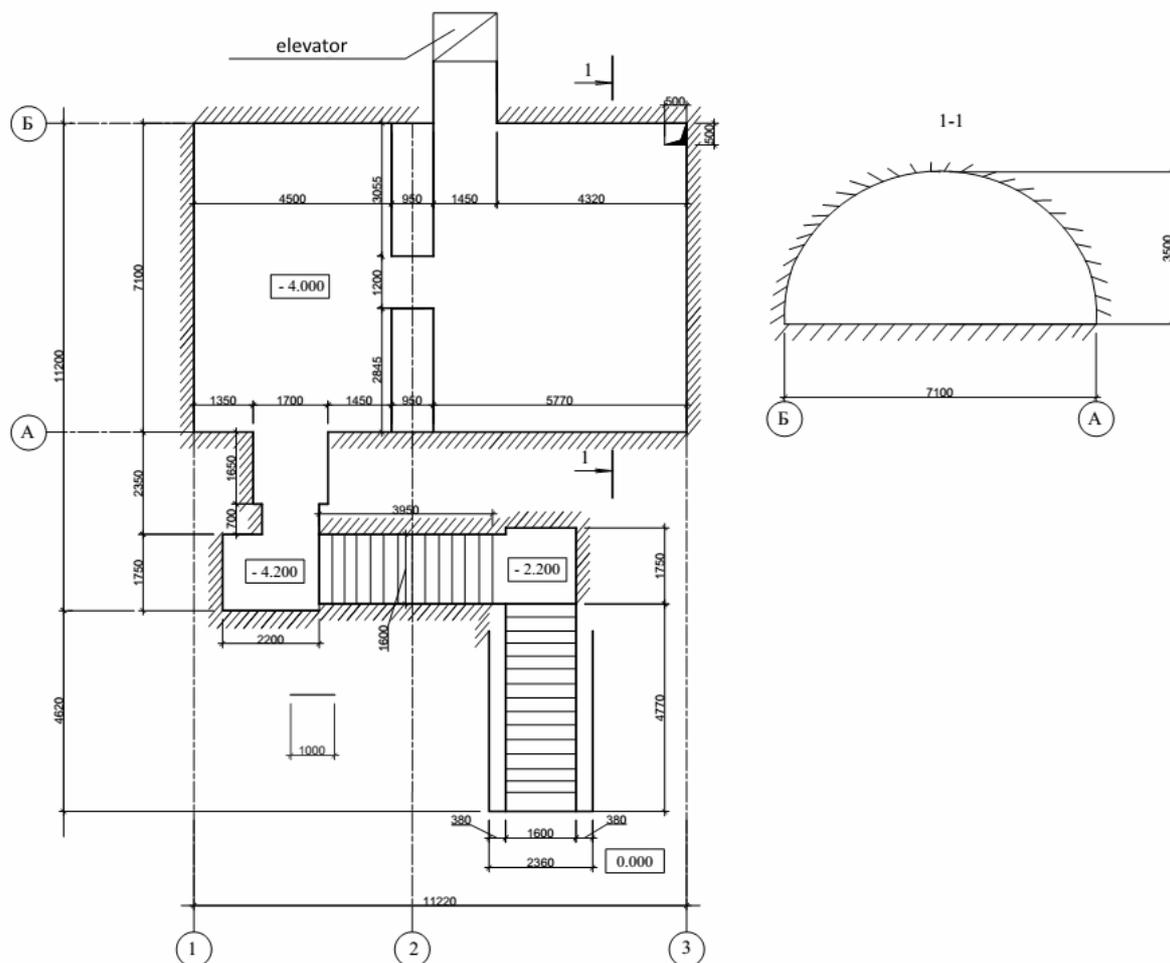
Figure 2 – Plan of the basement section, which was available for inspection

During the preliminary survey, structures measurements and building basement drawing were made (Fig. 2). In the course of measuring works, the location, bearing elements thickness, conditions and quality of structural elements joining, structures deformation, destruction, places of moisture and other defects were determined.

The general characteristic of the basement technical condition, which was available for inspection, can be estimated as «satisfactory» – the elements of the building in general are suitable for operation, but require renovation, which is most expedient at this stage. In some places cracks and fallout bricks are found. Walls are damp. At the entrance to the basement room, place of excessive moisture and water accumulation was found, which leads to the soaking of the basis.

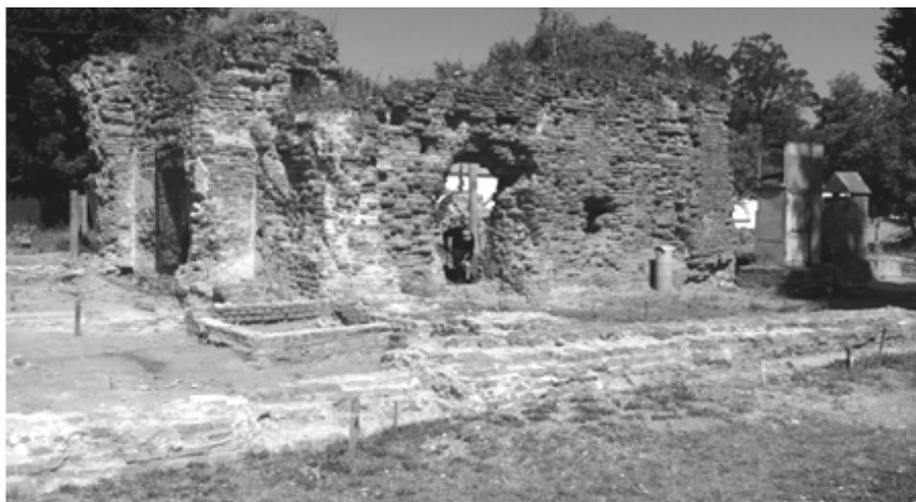
The general characteristic of the superstructure technical condition can be estimated as «emergency» – the state of bearing structural elements remains needs to be restored. The overlap is destroyed; the wall brickwork has undergone significant destruction (brick and mortar removal, lintel fallout).

- a) – general view of the building superstructure remains;
- b) – destruction of masonry lintel at the basement entrance;
- c) – destruction of the house socle;
- d) – temporary fastening of the overlap remains;
- e) – destruction of the brick lintel and entrance posts.

2. Superstructure needs major renovation.
3. The primary objectives are:
 - protection of existing structures from external influences (weathering, excessive humidification, freezing of structures) by arrangement of pavement around the building, installation of drainage and waterproofing systems, plastering and application of waterproofing solutions on the wall and socle elements, temporary roof installation;
 - reinforcement of separate structure elements by metal overlays arrangement, tightening and concreting of weakened elements;
 - execution of architectural drawings of the house facades aimed to renovate the house in its original form;
 - execution of integrated project on historical building restoration.
