INVESTIGATION OF GROUND AND FOUNDATION CONDITION INFLUENCE ON THE SPASO-PREOBROZHENSKAYA CHURCH CONSTRUCTIONS IN POLOTSK

In the article the problems of the XII century architecture monument preservation – Spaso-Preobrazhenskaya church of Spaso-Efrosinievskiy convent in Polotsk are considered. A brief reference is given on the technical condition and design features of the facility. Various parameters research results allows to estimating bearing constructions technical condition. The issues of bearing structure geodetic, visual, instrumental and electronic remote monitoring complex implementation and organization are considered. The issues of innovative technology introduction for this research area such as ground-based three-dimensional laser scanning are covered. There was made a conclusion church foundation conditions and there are given recommendations as for their strengthening.

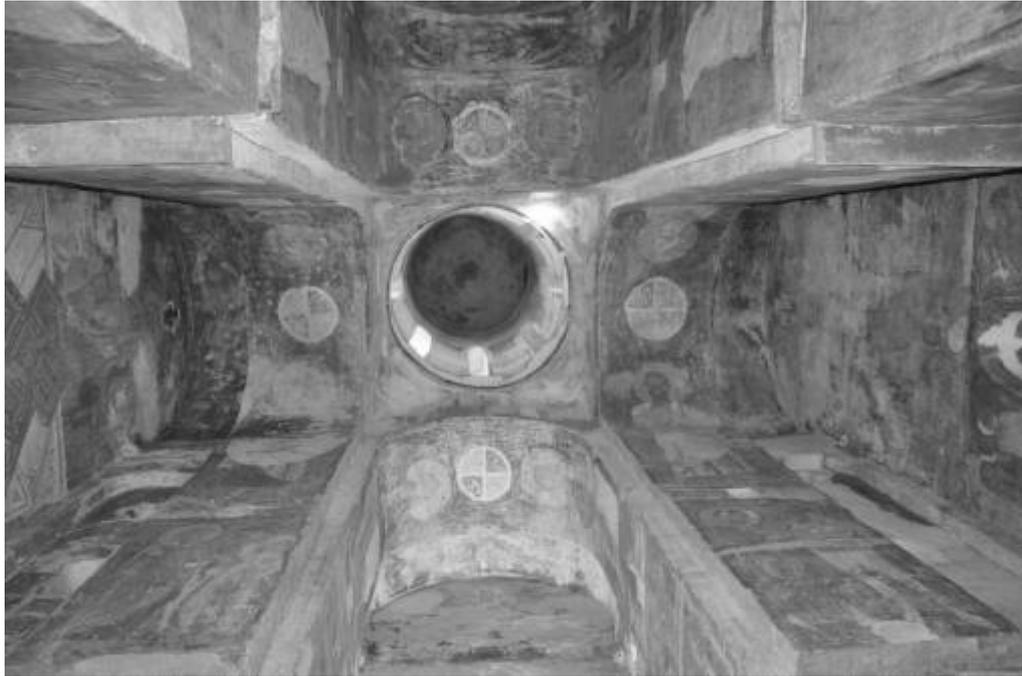
**Figure 2 – General view of the church structure.
On the walls, arches, pillars, there is a fresco painting of the 12th century**

The planned restoration of the fresco painting began in the early 90s of the last century and has not been completed yet (Figure 2).

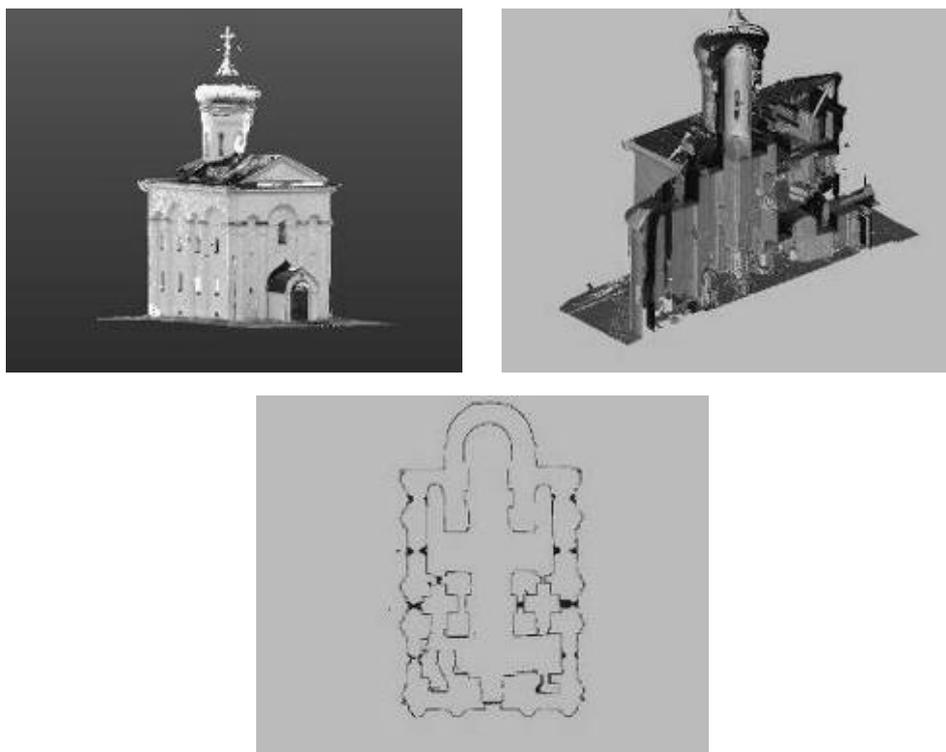
Figure 5 – Some results of a three-dimensional ground-based laser scanning of a church building. General view of the points cloud, a cut, a plan in the level of the choir

The obtained scan results were subsequently transferred to correct the calculation model, performed in accordance with the previously existing approximate dimensional drawings. It should be noted that the application of the above technology allows making the amount of work that various specialists have tried to do for many decades (Figure 5).
